RAIN EVENT NARRATIVE

Rain Event Program Narrative Lower Passaic River Restoration Project 1 of 8

Lower Passaic River Restoration Project

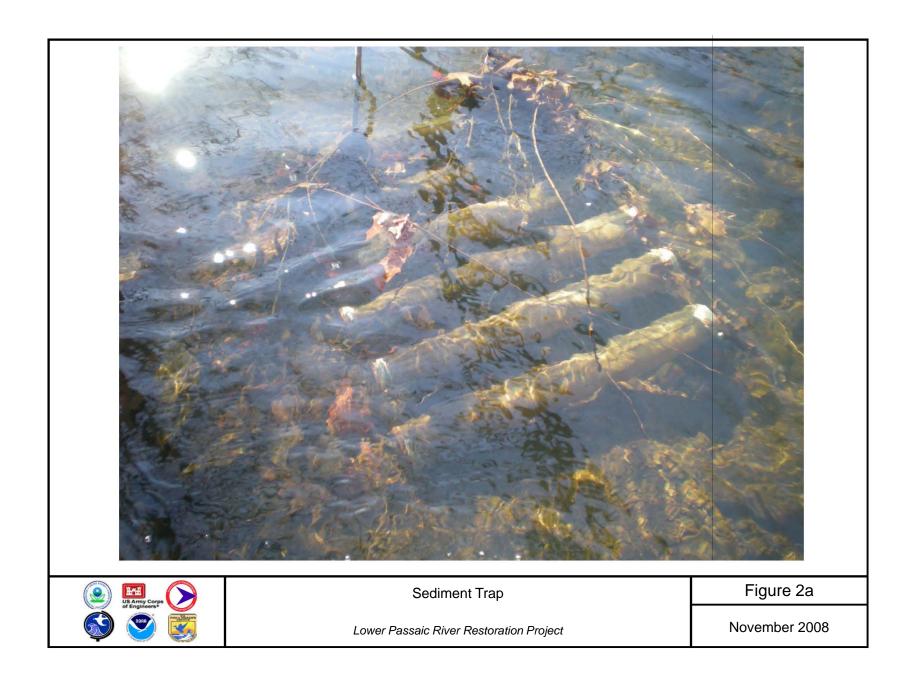
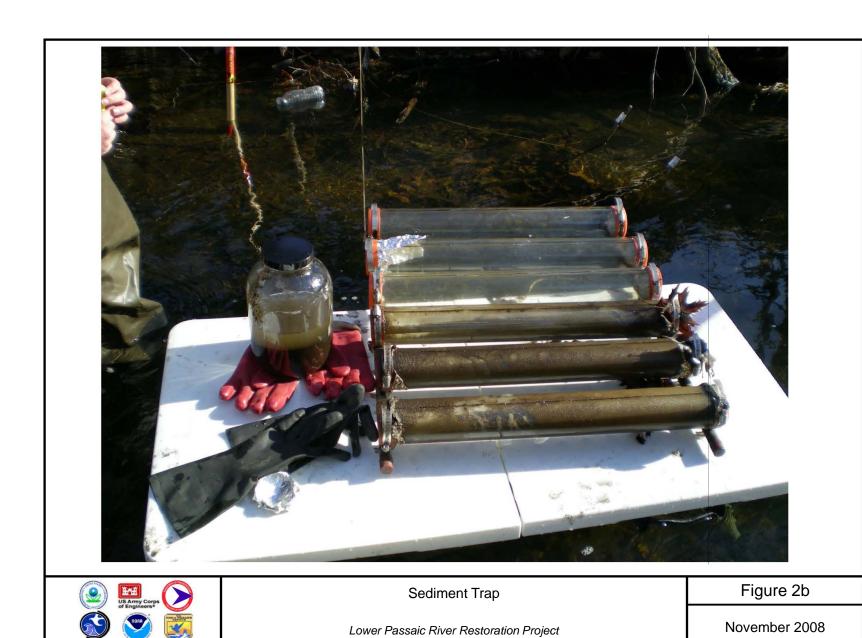
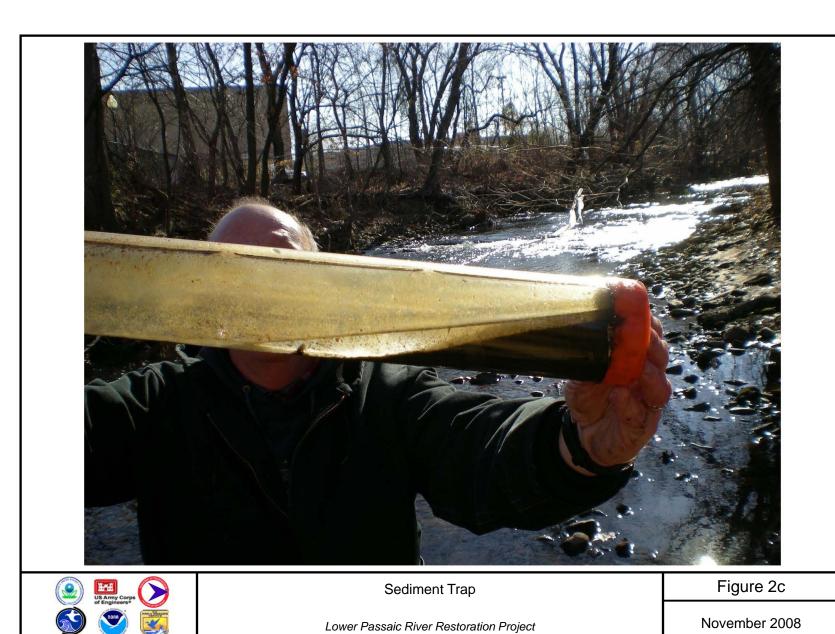
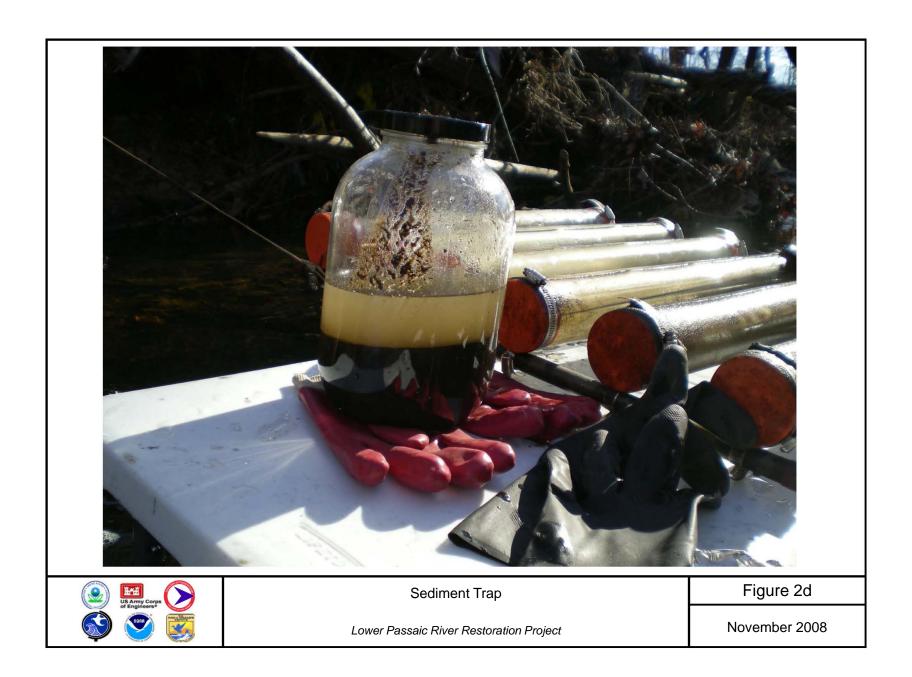
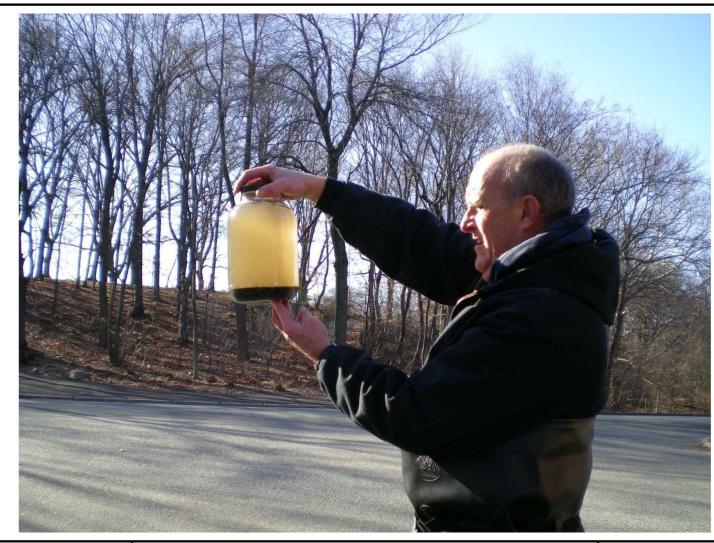
Figure 2e

Sediment Trap

In addition to the water column samples, sediment traps were also deployed on the tributaries. These traps were designed to collect recently depositing solids on tributaries that exhibited extremely low amounts of suspended solids during periods of low flow (non-rain events). Traps were constructed of four to six tubes (Figure 2). Each of the two-foot long sediment trap tubes had a slot cut along the top of the tube from end to end. A small spacer remained approximately every foot to keep the tube from collapsing on itself. A lattice was constructed, and the tubes were affixed to it. The lattice was deployed into the tributary bottom with the tube slots facing upward. Each lattice was attached to a safety line that was staked at the shore. The lattice was also held down using rocks, where necessary. Due to the extremely high flow rates through the Second River channel, the lattice was also staked directly to the river bottom. This security was necessary after a set of sediment traps was washed away, also breaking the rope used as a safety line.

The sediment traps were deployed for a few weeks in the tributaries over the course of a few rainfall events. Sediment trap were deployed three times between December 2007 and March 2008. The first deployment extended from December 27, 2007 to January 16, 2008; the second deployment extended from January 17, 2008 to February 7, 2008; and the third deployment extended from February 20, 2008 to March 10, 2008. They were inspected regularly until a sufficient volume of sediment had accumulated in each of the traps. The traps were retrieved and the sediment in the tubes was placed into a decontaminated glass jar and allowed to settle overnight (Figure 2). The following day
